## Driver Can't Hear Staff (Outbound Audio)

Diagnostic and resolution reference for the Pro Intercom System (K3): the outside driver cannot hear staff speaking. Outbound path: base station or headset → outdoor speaker.

**Applies to:** Pro Intercom System AIO-K3-L1 and AIO-K3-L2, and the Pro Bundles AIO-BNDL-K3L1-MBW2P and AIO-BNDL-K3L1-MBW2P-CAM. Some base stations and headsets are physically labeled *HuaFone*; they are the same Avio product and this guide applies to them.

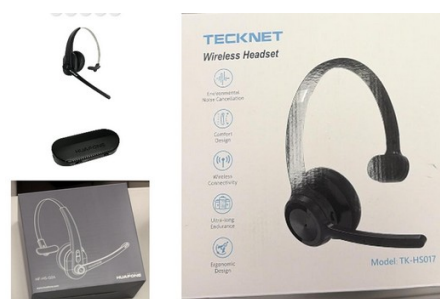
**Current systems** ship a TeckNet TK-HS017 as the Listen-In headset, so the two are different brands and shapes and easy to tell apart at a glance.

**Systems shipped before this change** used the same model for both roles; they look identical and only the label tells them apart. If your headsets match, check the label every time, and keep the two on separate chargers.

Earlier Listen-In headset with transmitter/charger (left); current TeckNet TK-HS017 Listen-In headset (right)

| # | Root cause | Fix |
|---|---|---|
| 1 | <b>Wrong headset in use:</b> the receive-only Listening headset is being worn instead of the Main headset. | Check the label on the headset being worn; it must read "Main". Separate or color-code the charging areas so it cannot recur. |
