# CASE STUDY: **INCORRECT LAYOUT**

## When Using A Non-Integrated Menu Board

# CASE STUDY: **CORRECT LAYOUT**

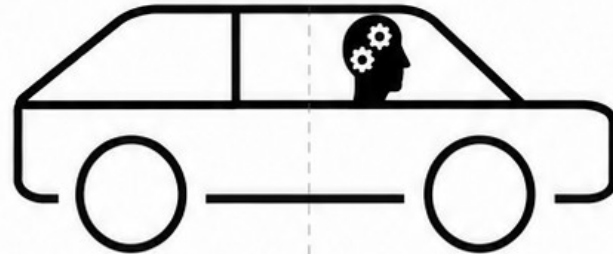
The system **mutes** if the driver is out of the post sensor's view.

### MISALIGNED SENSOR/MIC/SPKR POST

The SENSOR/MIC/SPKR POST is on the far left of the menu board.

### INCORRECT ANGLE

The SENSOR/MIC/SPKR POST is angled away from the driver.

### POOR COMMUNICATION

Driver hears less clearly, especially in noisy environments.

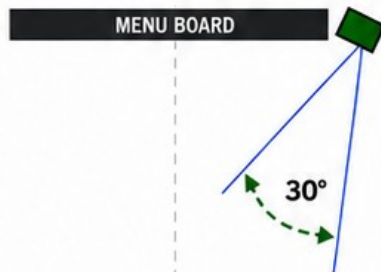
### OPTIMAL ALIGNMENT

The SENSOR/MIC/SPKR POST is positioned at the far right of the menu board.

### CORRECT ANGLE

The SENSOR/MIC/SPKR POST is angled 30° toward the driver for direct communication.

### CLEAR COMMUNICATION

Driver hears clearly, improving order accuracy and customer satisfaction.

Place the SENSOR/MIC/SPKR POST on the menu board and angle it 30° toward the driver for the best audio performance.

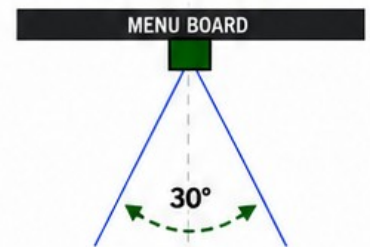
### OPTIMAL CENTER ALIGNMENT

The SENSOR/MIC/SPKR POST is positioned at the center of the menu board.

### CORRECT ANGLE

The SENSOR/MIC/SPKR POST is angled 30° toward the driver for direct communication.

### CLEAR COMMUNICATION

Driver hears clearly, improving order accuracy and customer satisfaction.
