## Staff Can't Hear the Driver (Inbound Audio)

Diagnostic and resolution reference for the Pro Intercom System (K3): the base station cannot hear the outside driver placing an order. Inbound path: speaker post microphone → base station.

**Applies to:** Pro Intercom System AIO-K3-L1 and AIO-K3-L2, and the Pro Bundles AIO-BNDL-K3L1-MBW2P and AIO-BNDL-K3L1-MBW2P-CAM. Some base stations and headsets are physically labeled *HuaFone*; they are the same Avio product and this guide applies to them.

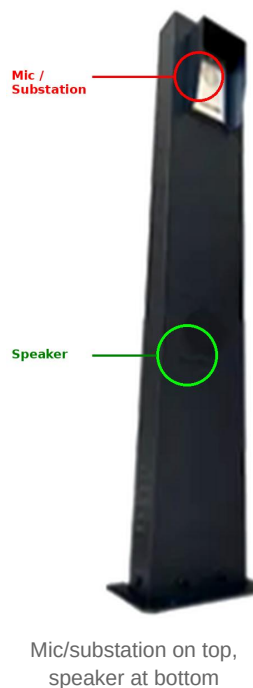
The speaker post combines two units in one housing:

- **Mic / substation unit**, at the top of the post: captures the driver's order (inbound path).
- **Speaker unit**, at the bottom of the post: plays staff audio back to the driver (outbound path).

Both are housed in the factory-installed ProPanel®, an aluminum unibody, weather- and vandal-resistant panel with a built-in vehicle sensor. The sensor **unmutes both the mic and the speaker when a vehicle arrives, and mutes them again about three minutes after the vehicle leaves**. Muting when no vehicle is present is normal behavior, not a fault.
